HOME INSPECTION

Service: Pre-Listing Inspection

Site Address: 10 Geysers Road, Saratoga Springs, NY, 12866

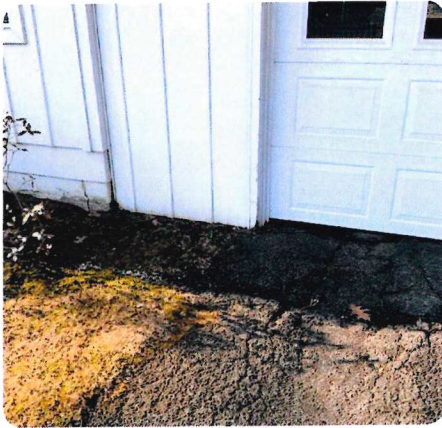
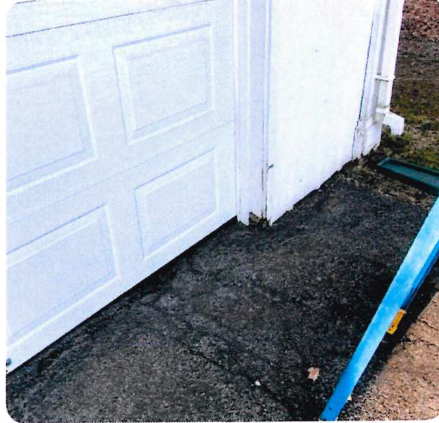
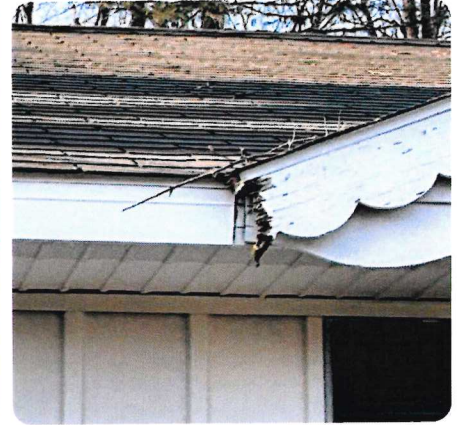
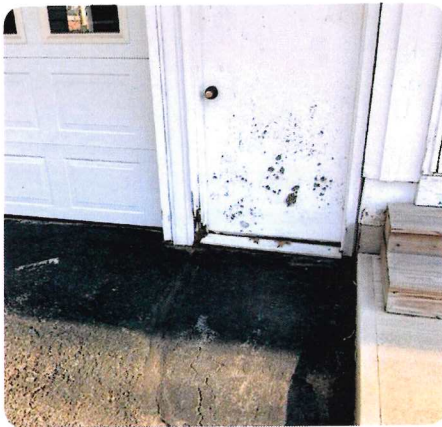
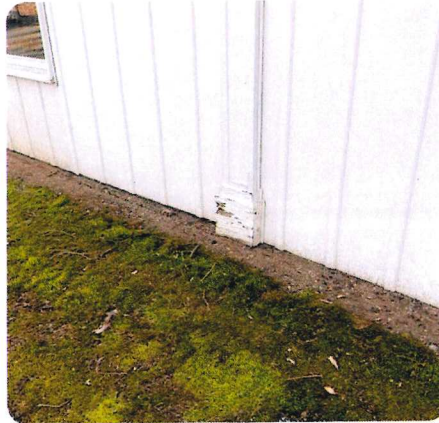
1 Damaged Trim

The trim needs repair. Addressing this issue is important as damaged trim affects the aesthetics of the home, and may lead to moisture intrusion. Repair or replacing the damage trim is recommended.

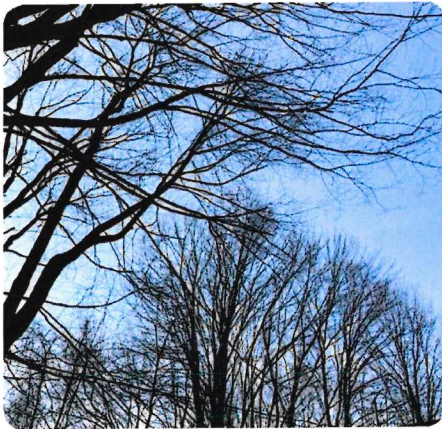
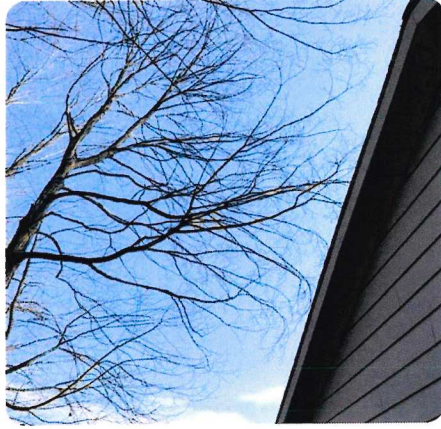
2 Overhanging Trees

The overhanging trees near the property can potentially pose a risk of falling branches or debris onto the roof, leading to damage. It is recommended to trim back the overhanging branches to prevent any potential hazards. We suggest evaluating and pruning the trees to maintain a safe distance from the property.

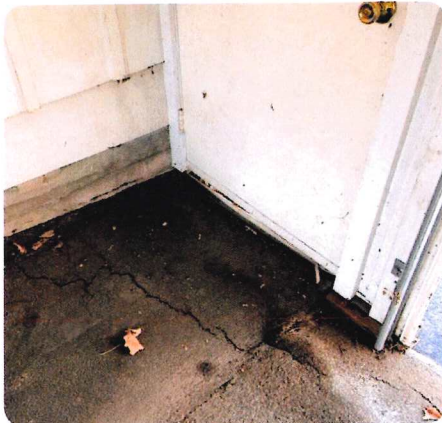
3 Door Threshold

The back garage door threshold needs to be replaced

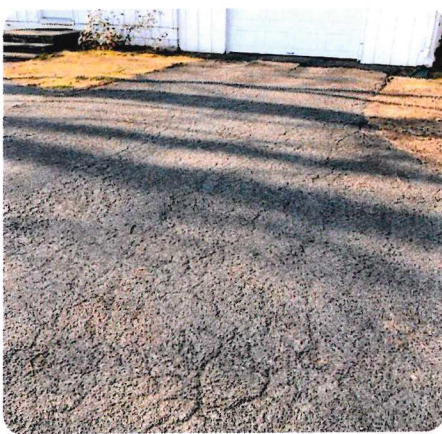
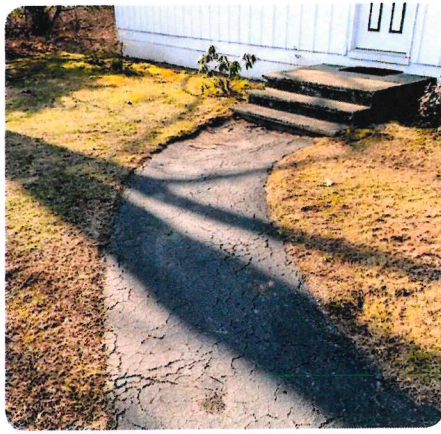
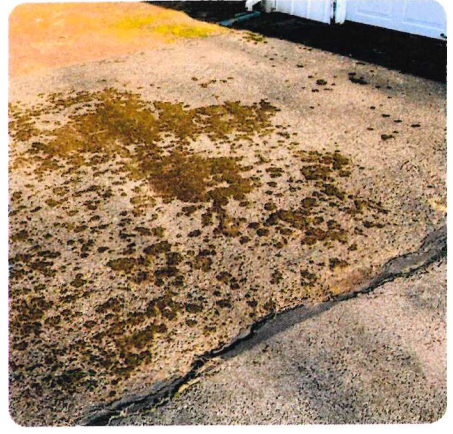
4 Evaluation Of Cracks On Walkways And Driveways

Cracks were observed on the walkways and driveways. This can lead to further damage if not addressed. It is recommended to repair the cracks to prevent tripping hazards and to extend the longevity of the walkways and driveways. A licensed contractor can evaluate and repair the cracks using appropriate materials and techniques, such as filling with a flexible sealant designed for outdoor use.

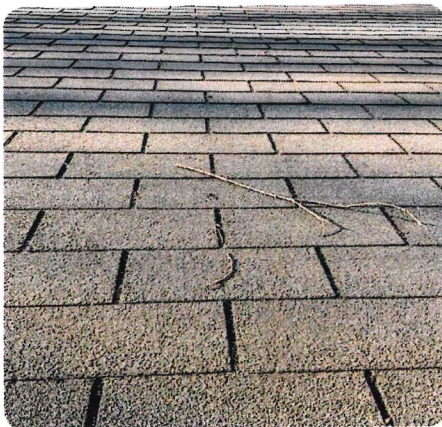
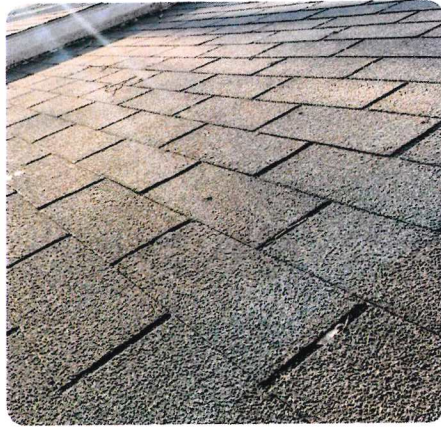
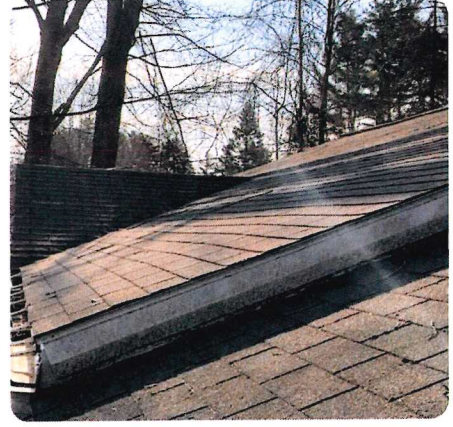
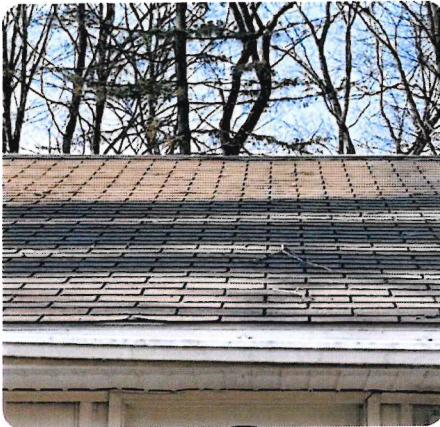
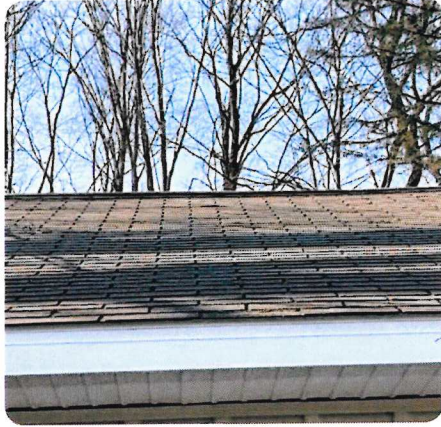
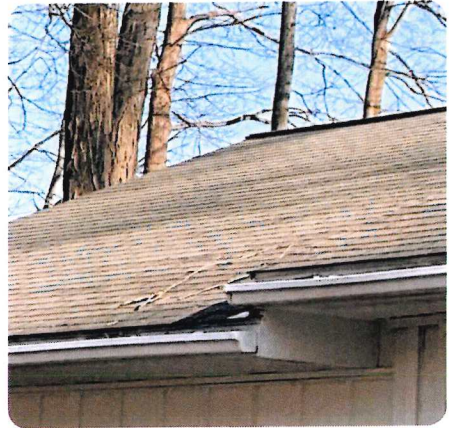
5 End-Of-Life Covering Alert

The roof covering is at the end of its life, indicating deterioration and potential inadequate protection. A qualified roofer should evaluate the roof for necessary repairs or replacement. Prompt attention is advised to prevent further damage to the underlying roof structure. The sheathing in the garage attic had water stains from leaks.

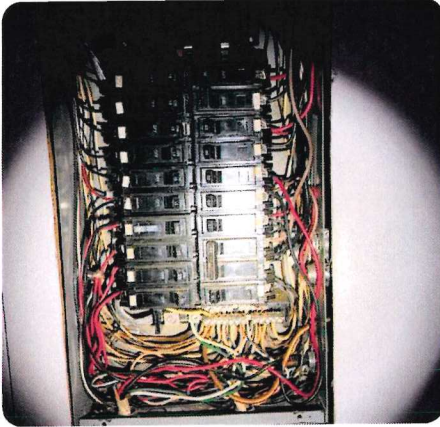
6 Double Tap Disconnect

The double tap arrangement of multiple wires connected to a single circuit breaker, also known as a double tap disconnect, is not up to current electrical code standards. This setup can lead to overheating, potential arcing, and poses a fire hazard. It is recommended to have a qualified electrician evaluate and repair this issue by installing a separate circuit breaker for each wire. Ensure proper connections to enhance safety and prevent electrical hazards in the home.

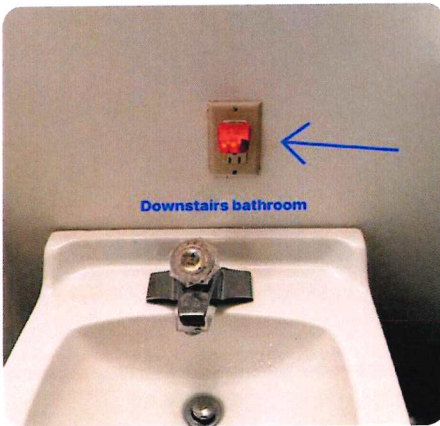
7 GFI Receptacle Not Functional

The GFI receptacle did not trip when tested. All receptacles in wet locations, on the exterior of a house or in the garage should be protected by a GFI circuit. The inspector recommends a qualified licensed electrician further evaluate the GFI and make recommendations for proper repair.

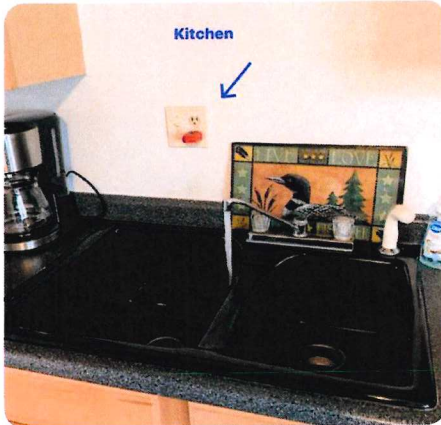
8 No GFCI Installed

No Ground Fault Circuit Interrupters (GFCI Circuits) were found at the structure. It is advised to install GFCIs in areas with a potential danger of electrical shock (living spaces and internal rooms, garages, exterior outlets, etc.) As a safety enhancement measure. We suggest contacting a qualified electrician for assessment and necessary repairs.

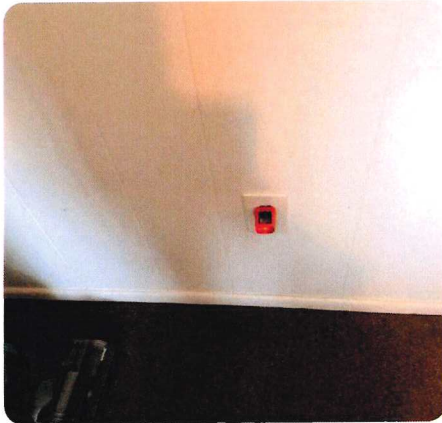
9 Open Ground Outlets

The outlets throughout the property have an open ground. It is recommended to evaluate and repair the open grounds by ensuring proper grounding for the safety of the electrical system. Qualified electrician should be hired to address and repair the open ground outlets. Replacing with proper grounded outlets or correcting the wiring can help rectify this issue.

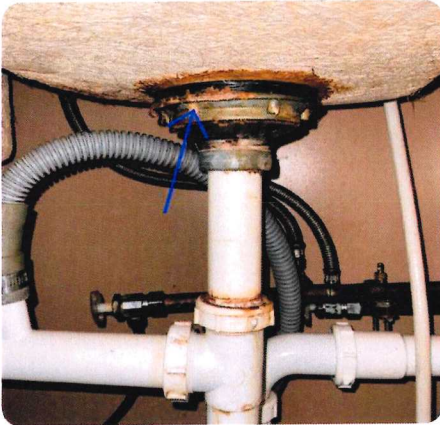
11 Sink Drain Pipe Leak

The drain is leaking underneath the sink. It is recommended to evaluate and repair the leak to prevent water damage to the surrounding areas. A qualified professional should be contacted to properly repair the leak and ensure that the drainage system is functioning effectively. Regularly checking for leaks in sink drains can help avoid costly water damage in the future.

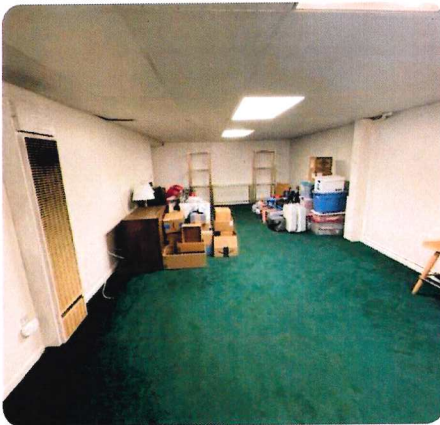
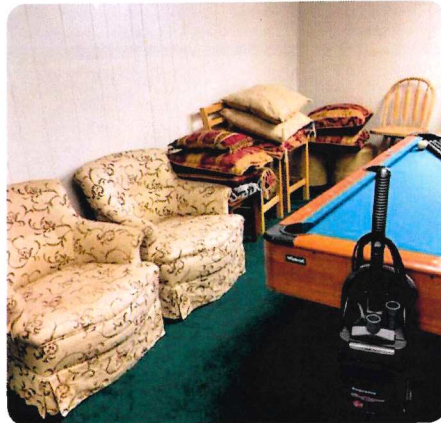
12 Storage

Furnishings and/or storage items in this home are more than normal. There were furnishings and/or stored items inside the home that limited the inspector's ability to visually inspect all areas of this home. Notation is made that the inspector does not move furniture or stored items in order to perform the inspection. Re-inspecting the home prior to closing is recommended as certain issues may become visible once the structure is vacated.

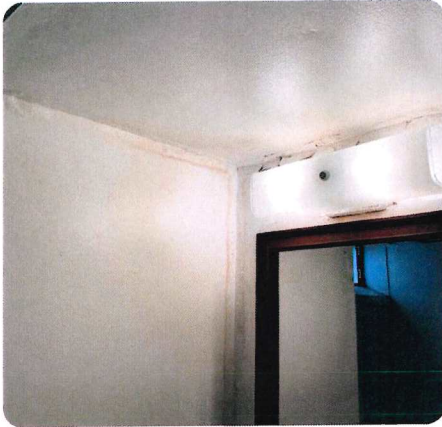
13 Walls Repair/Paint Needed

The bathroom downstairs has water stains and some mold which should be removed and replaced. Repair/paint is needed at multiple locations on the walls, enhancing the aesthetic appeal of the interior space and preventing further damage. Evaluating and repairing these areas will contribute to maintaining the overall condition of the walls.

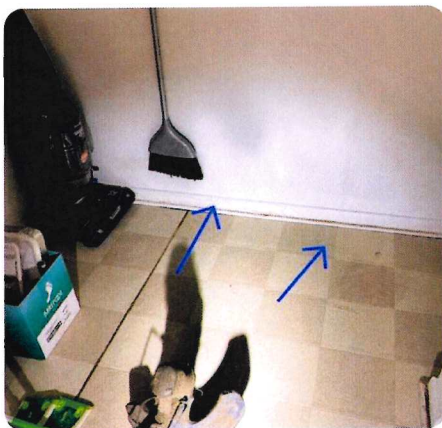
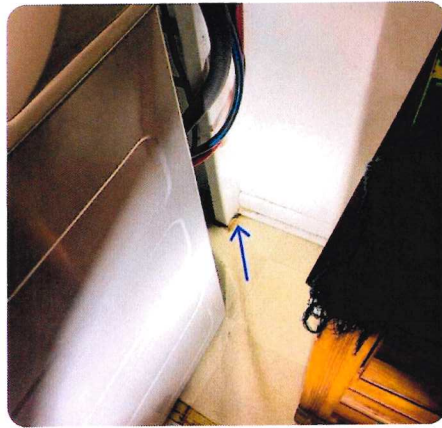
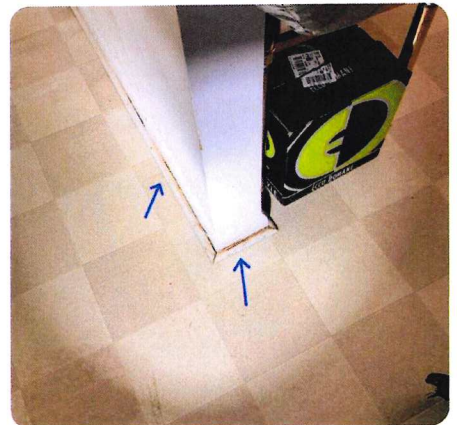
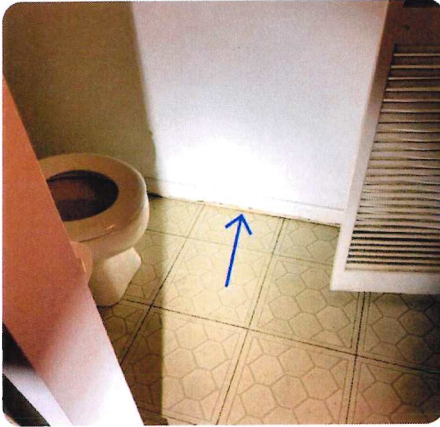
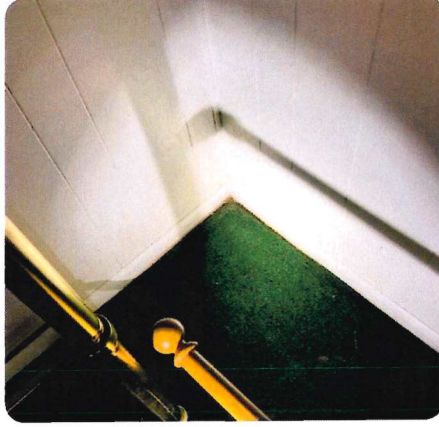
16 Evidence Of Moisture Intrusion **✚ Repairs Recommended**

Evidence of moisture intrusion on the wood baseboard was observed, looks to be from the past. The areas should be cleaned and painted.

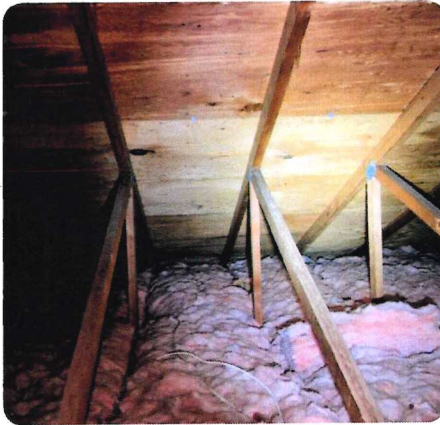
17 Blocked Soffit Vents By Insulation

The soffit vents in the attic are blocked by insulation. This can restrict proper airflow in the attic, leading to inadequate ventilation. It is recommended to evaluate and repair this issue by clearing away any insulation blocking the soffit vents to ensure sufficient ventilation in the attic. A qualified insulation contractor can help in this repair process.

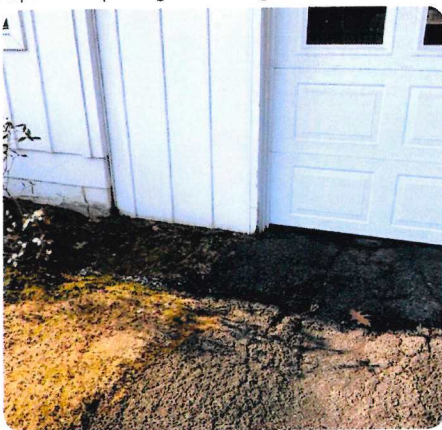
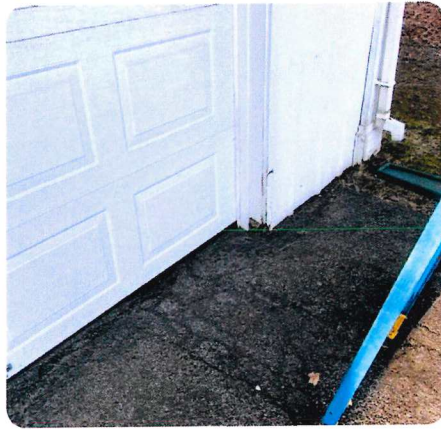
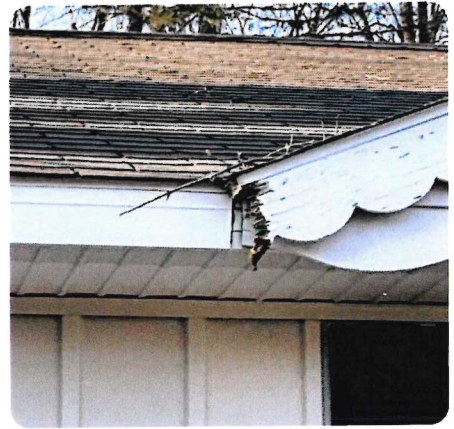
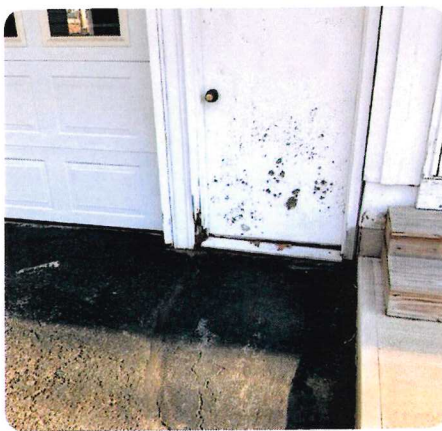
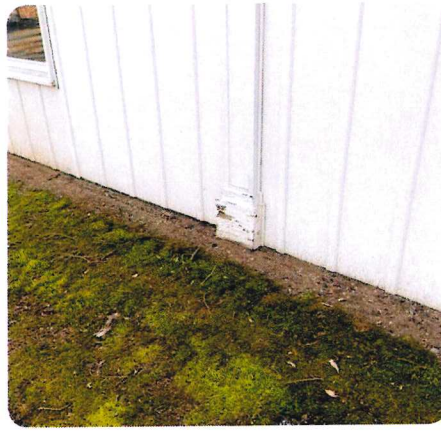
Damaged Trim (Included in Summary) ✘ Repairs Recommended

The trim needs repair. Addressing this issue is important as damaged trim affects the aesthetics of the home, and may lead to moisture intrusion. Repair or replacing the damage trim is recommended.

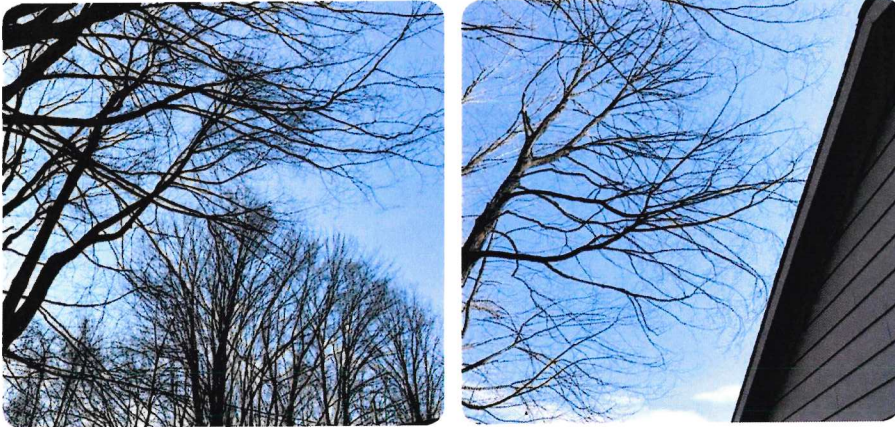
Overhanging Trees

The overhanging trees near the property can potentially pose a risk of falling branches or debris onto the roof, leading to damage. It is recommended to trim back the overhanging branches to prevent any potential hazards. We suggest evaluating and pruning the trees to maintain a safe distance from the property.

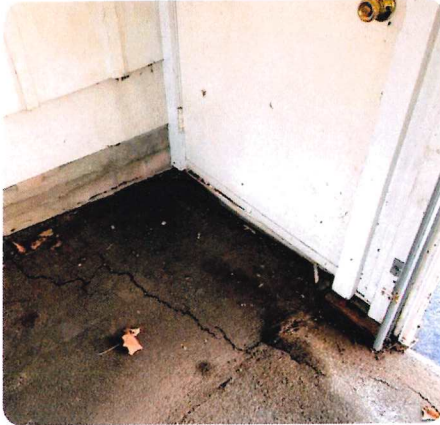
Door Threshold

The back garage door threshold needs to be replaced

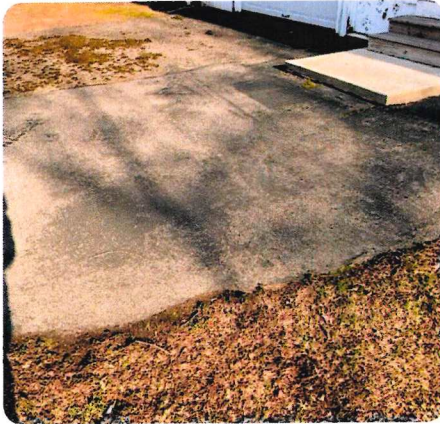
Wear And Safety Check

Each area was checked for signs of wear such as cracking, settling, or erosion that could impact usability and safety. The surfaces were found to be serviceable at the time of the inspection.

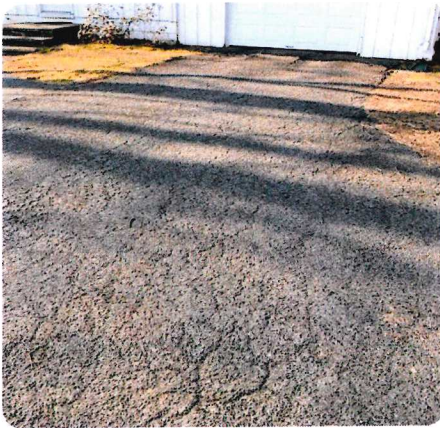
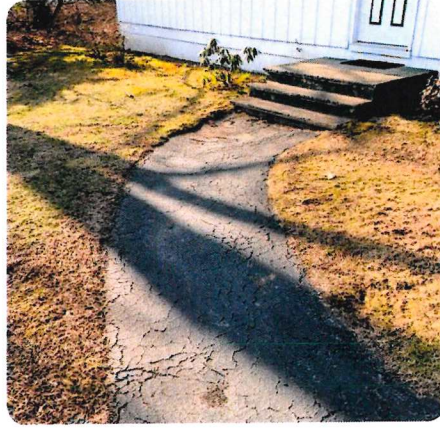
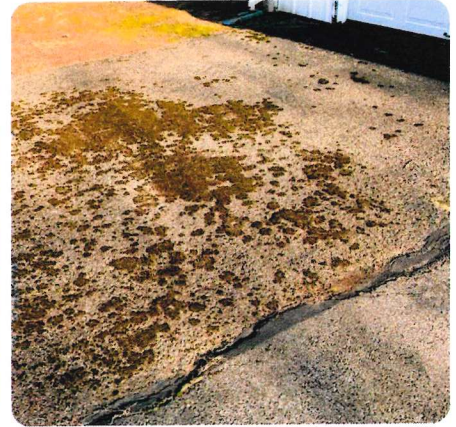
Evaluation Of Cracks On Walkways And Driveways

Cracks were observed on the walkways and driveways. This can lead to further damage if not addressed. It is recommended to repair the cracks to prevent tripping hazards and to extend the longevity of the walkways and driveways. A licensed contractor can evaluate and repair the cracks using

appropriate materials and techniques, such as filling with a flexible sealant designed for outdoor use.

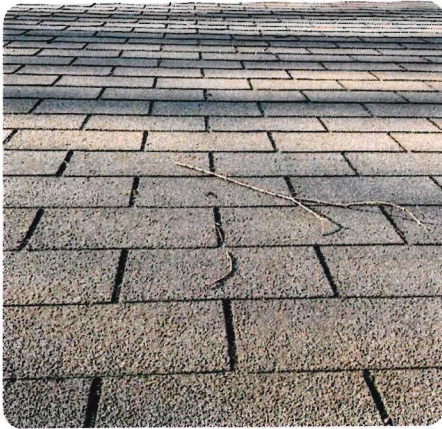
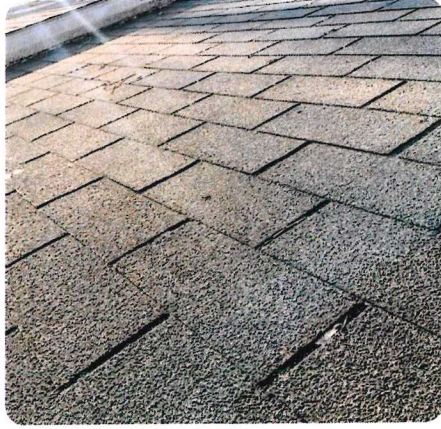
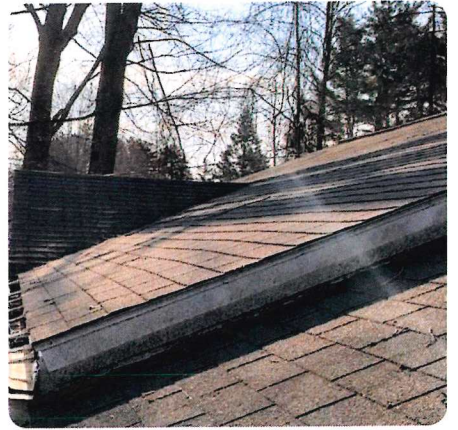
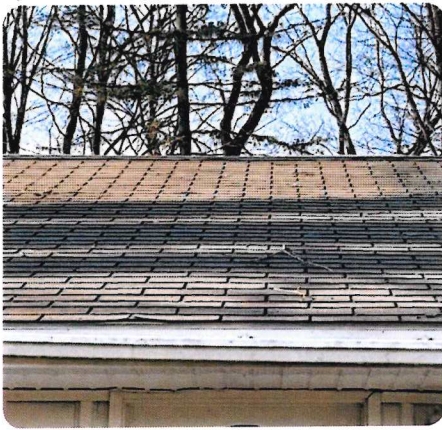
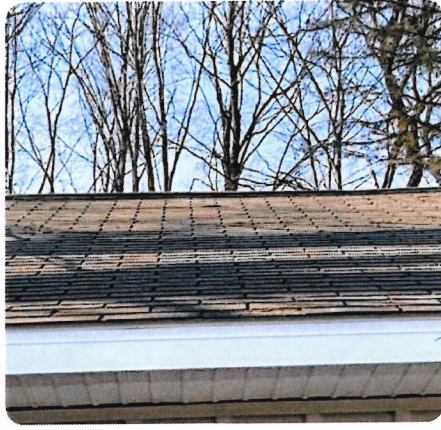
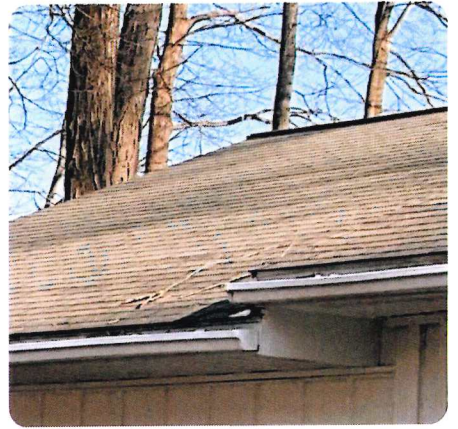
End-Of-Life Covering Alert

The roof covering is at the end of its life, indicating deterioration and potential inadequate protection. A qualified roofer should evaluate the roof for necessary repairs or replacement. Prompt attention is advised to prevent further damage to the underlying roof structure. The sheathing in the garage attic had water stains from leaks.
