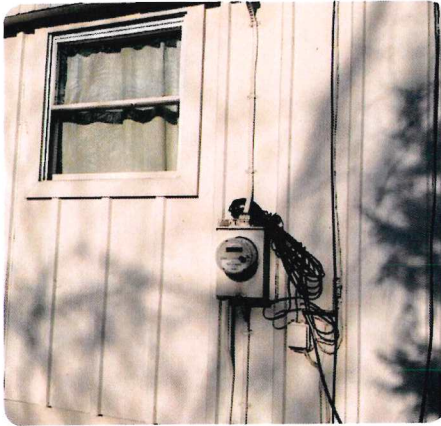
Service Entrance And Grounding Evaluated ✔ Functional

The service entrance components and grounding system were in serviceable condition at the time of the inspection.

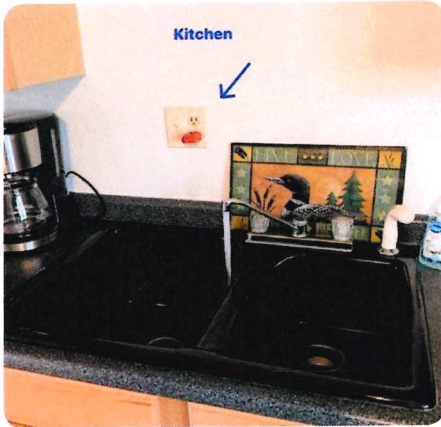
No GFCI Installed (Included in Summary) ⚠ Repairs Recommended

No Ground Fault Circuit Interrupters (GFCI Circuits) were found at the structure. It is advised to install GFCIs in areas with a potential danger of electrical shock (living spaces and internal rooms, garages, exterior outlets, etc.) As a safety enhancement measure. We suggest contacting a qualified electrician for assessment and necessary repairs.

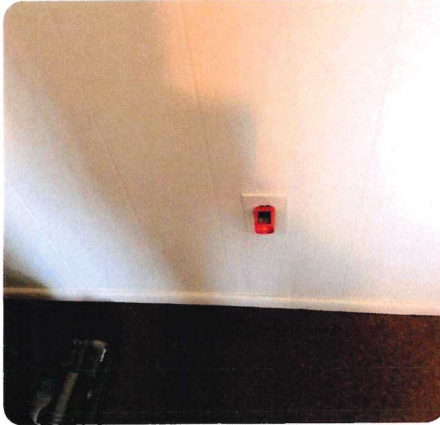
Open Ground Outlets

The outlets throughout the property have an open ground. It is recommended to evaluate and repair the open grounds by ensuring proper grounding for the safety of the electrical system. Qualified electrician should be hired to address and repair the open ground outlets. Replacing with proper grounded outlets or correcting the wiring can help rectify this issue.

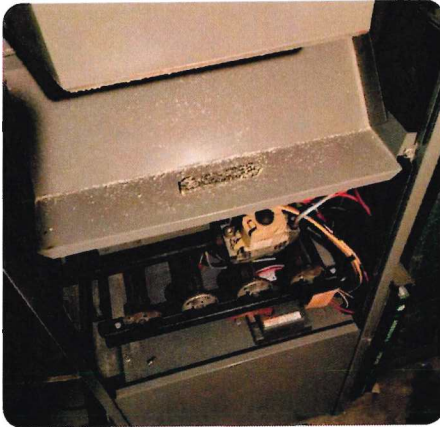
Operational Furnace

The heating system was on/off tested and found to be operational under normal operating procedures. A conventional gas-fired forced air furnace contains a heat exchanger with an average life expectancy of twenty to twenty-five years from the date of installation, though there have been exceptions on both sides. If a heat exchanger develops a crack, small hole, or fails, carbon monoxide can leak into the heating air stream, creating an unsafe condition. If there are not current service notes at the time of the inspection the inspector recommends. to have the furnace professionally serviced according to the manufacturer's specifications before the closing.

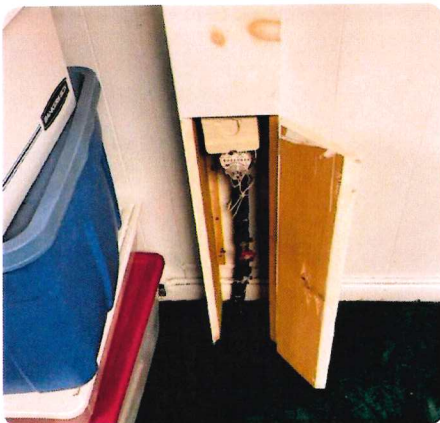
Water Main Shut-Off

The water main shut-off valve was located and evaluated during the inspection. It is important to know the location and condition of the shut-off valve in case of emergencies or repairs. We recommend testing the shut-off valve periodically to ensure proper functionality.

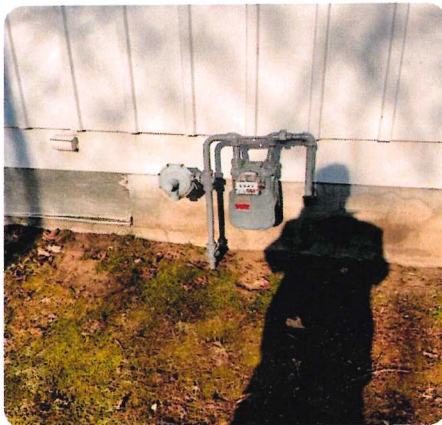
Visible Gas Supply Lines Inspected Functional

The gas plumbing system was evaluated during the home inspection and was found to be in functional working condition. No issues were identified with the gas plumbing system, assuring its functionality and safety for the occupants. Regular maintenance and inspection are recommended to ensure continued optimal performance.

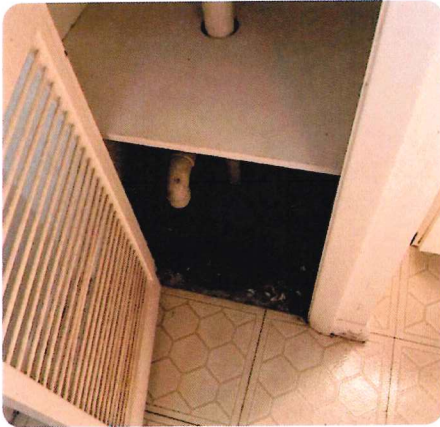
Waste Ejector

The waste ejector appeared to be functional at the time of the inspection. We recommend periodic inspections of the system for long term functional use.

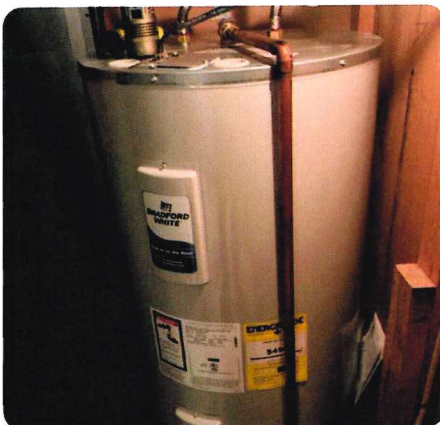
Water Heater

The water heater was visually inspected. The life expectancy of a water heater is typically 8-12 years from the date of installation, although there are exceptions on both sides. As a preventative maintenance recommendation, the water heater should be drained periodically to remove sediment buildup in the tank. The recommended setting for a residential water heater is under 120 degrees Fahrenheit. for safety.

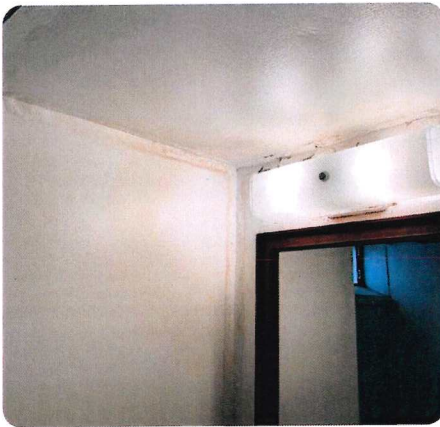
Walls Repair/Paint Needed

The bathroom downstairs has water stains and some mold which should be removed and replaced. Repair/paint is needed at multiple locations on the walls, enhancing the aesthetic appeal of the interior space and preventing further damage. Evaluating and repairing these areas will contribute to maintaining the overall condition of the walls.

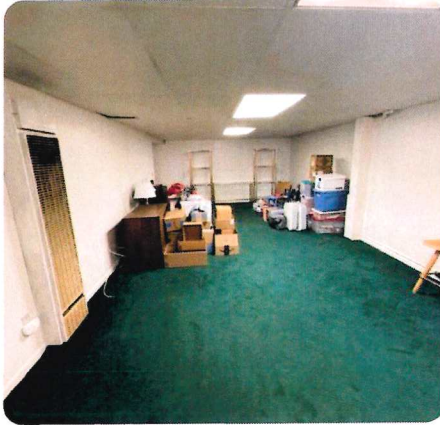
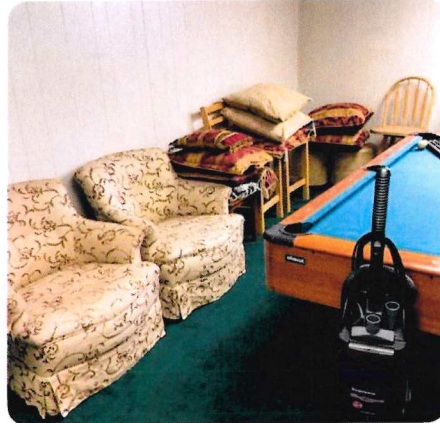
Storage

Furnishings and/or storage items in this home are more than normal. There were furnishings and/or stored items inside the home that limited the inspector's ability to visually inspect all areas of this home. Notation is made that the inspector does not move furniture or stored items in order to perform the inspection. Re-inspecting the home prior to closing is recommended as certain issues may become visible once the structure is vacated.

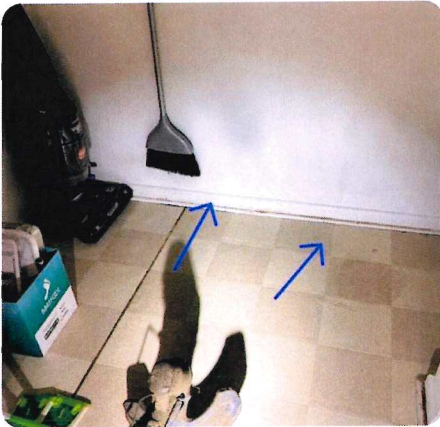
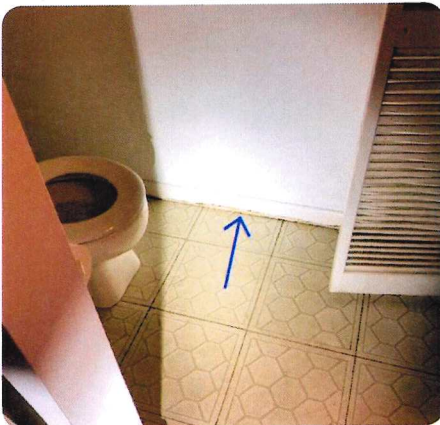
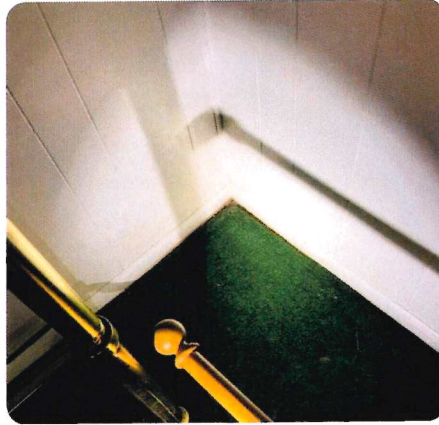
Evidence Of Moisture Intrusion 📄 (Included in Summary) 🔧 Repairs Recommended

Evidence of moisture intrusion on the wood baseboard was observed, looks to be from the past. The areas should be cleaned and painted.

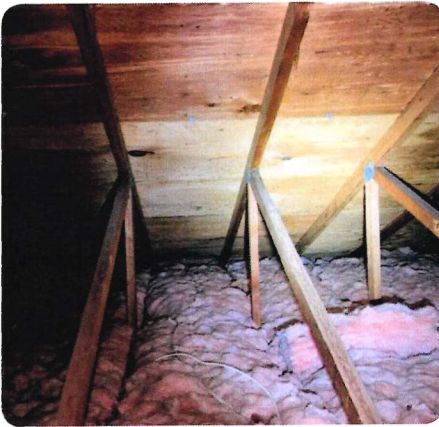
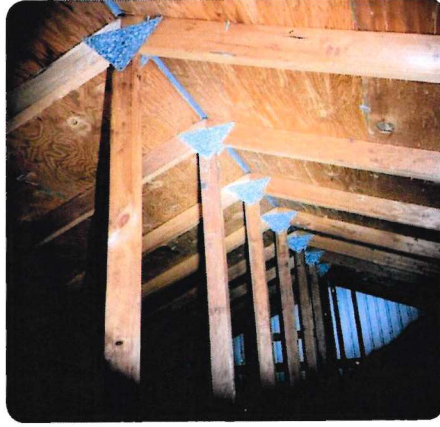
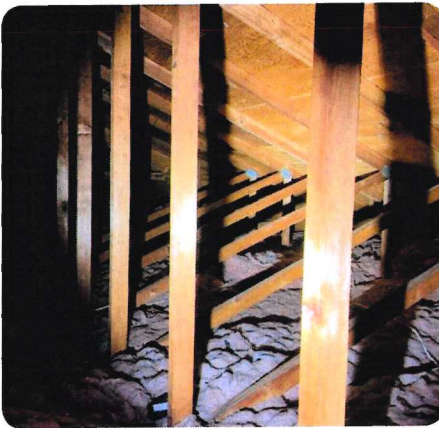
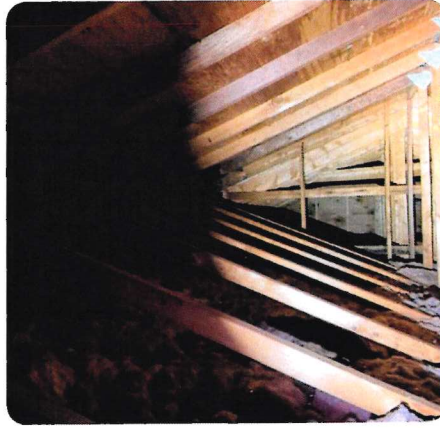
Roof Structure And Components Evaluated

The accessible internal roof components - including trusses, rafters, and sheathing, were examined and found to be functional. The inspection focused on identifying signs of deflection, deterioration, or damage, such as water staining or wood decay, and these items were serviceable at the time of the inspection.

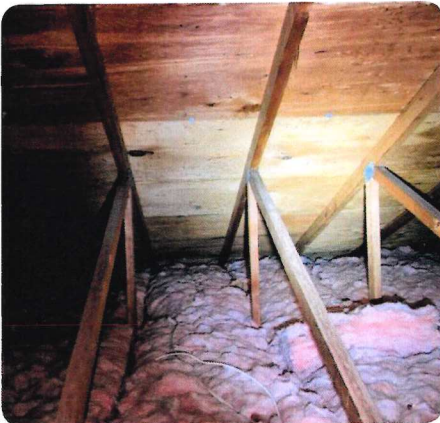
Blocked Soffit Vents By Insulation

The soffit vents in the attic are blocked by insulation. This can restrict proper airflow in the attic, leading to inadequate ventilation. It is recommended to evaluate and repair this issue by clearing away any insulation blocking the soffit vents to ensure sufficient ventilation in the attic. A qualified insulation contractor can help in this repair process.
